## Bacteriological quality characterization of a primary water source in Aba Oyo Community, Akure, Nigeria.

\*E. A. Erhuanga and O. O. Fadairo

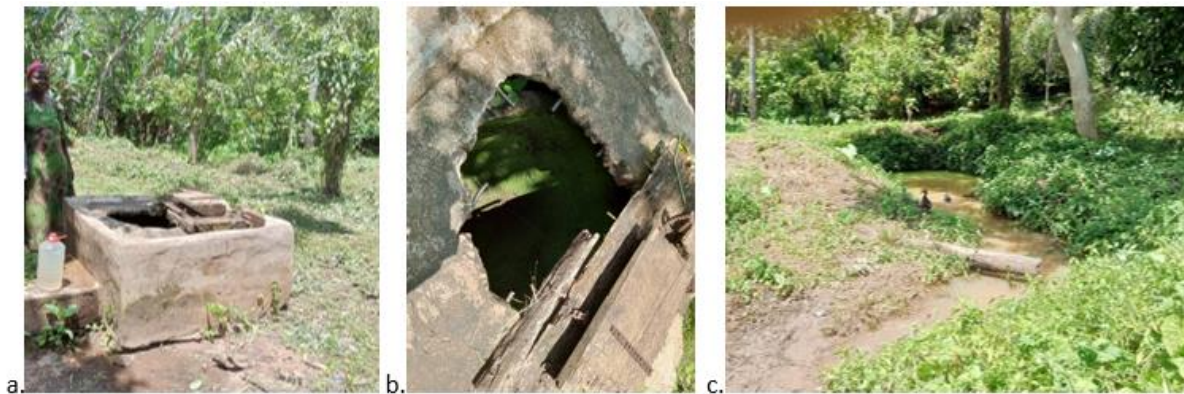
Figure 2: Water sources in Aba-Oyo a) The well b) The well opening with cover c) The pond

However, the maintenance of the well appears to be very poor. The well has a wooden cover which is mostly broken off, leaving most of the top of the well uncovered. Also, the top rings of the well are mostly covered in green matter (algae) and insects and organic life forms such as cockroaches can be seen crawling around the insides of the well cover. Though there is a dedicated fetcher attached to the well, it seems to lack frequent washing.

The well also appears poorly constructed; there is no flooring around the well head to prevent the pooling of water at the well. The surrounding is bushy and could possibly harbour open defecation within a few meters from the well. Lastly, the well is not fenced off to avoid animals having direct access to the well.

Therefore, it is advised that interventions be designed to educate the people on good sanitation and hygiene practices, disinfect the community-owned well, as well as provide an alternative source of water or a household treatment option as a temporary measure to meeting the safe water needs of the Aba-Oyo community. This study recommends that the Local and State Governments in partnership with donor
